ST. JOSEPHS LAKE DAM

SULLIVAN COUNTY, NEW YORK
INVENTORY No. NY 324

PHASE I INSPECTION REPORT NATIONAL DAM SAFETY PROGRAM

Name of Dam:	St. Josephs Lake Dam (I.D. No. NY 324)
State Located:	New York
County Located:	Sullivan
Stream:	Black Brook (tributary of Mongaup River)
Date of Inspection:	October 20, 1978

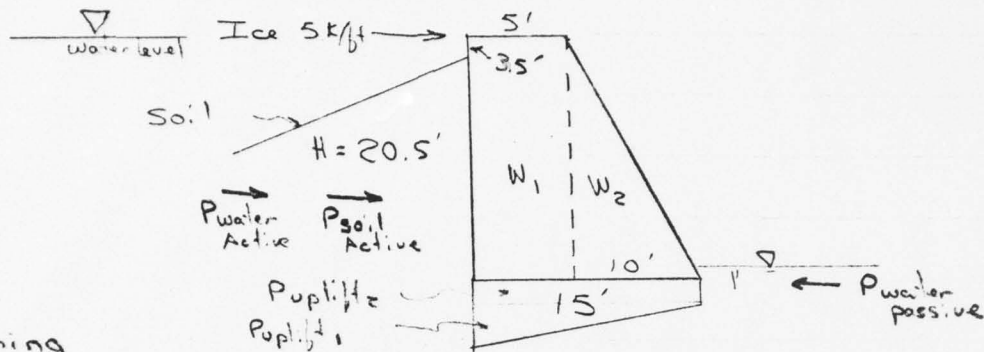
Stability Analysis

$$\text{F.S. Sliding} = .51$$

Since the dam has withstood these forces without failure (note low sliding factors of safety) the assumed geometry must be incorrect and this analysis invalid. Need More Info.
